## Appendix 5 – Report of site inspection, 15<sup>th</sup> April 2015

**Re: EU Pilot 5450/13 concerning Gearagh SAC and report of site inspection 15<sup>th</sup> April 2015.**

### **Report of Site Visit**

### Site Damage Assessment

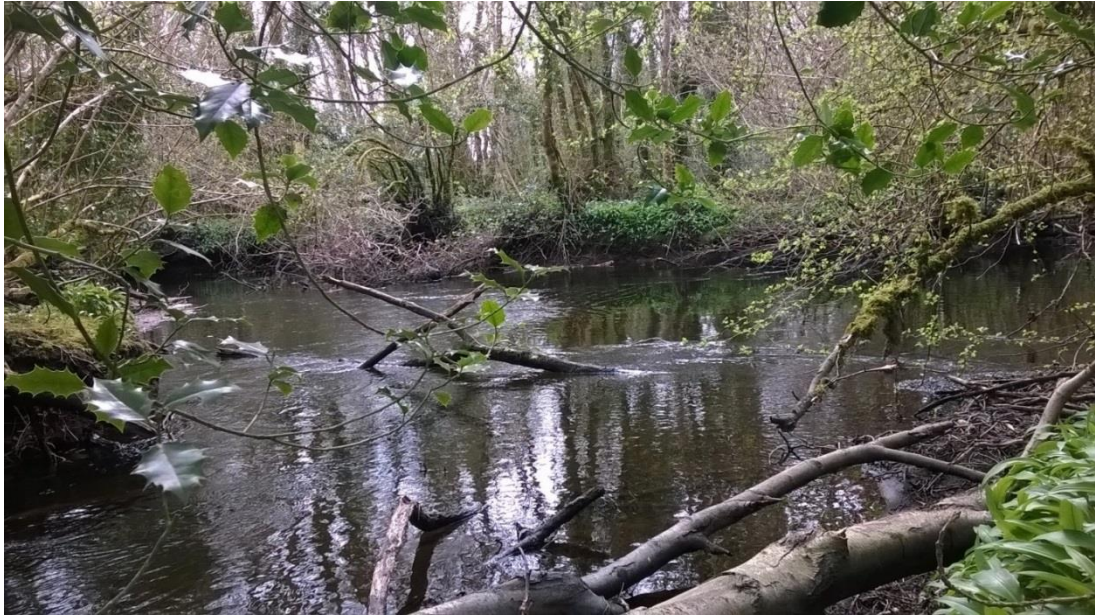
The contrast between Pictures 1 and 2 illustrates the point above, picture 1 showing the pattern of shallow river channels in the area and picture 2 showing some evidence of local erosion or throw of root systems in the central Toon River channel part of The Gearagh SAC, probably as a result of a recent flooding event.

### 1: Picture of the typical myriad of shallow river channels in The Gearagh

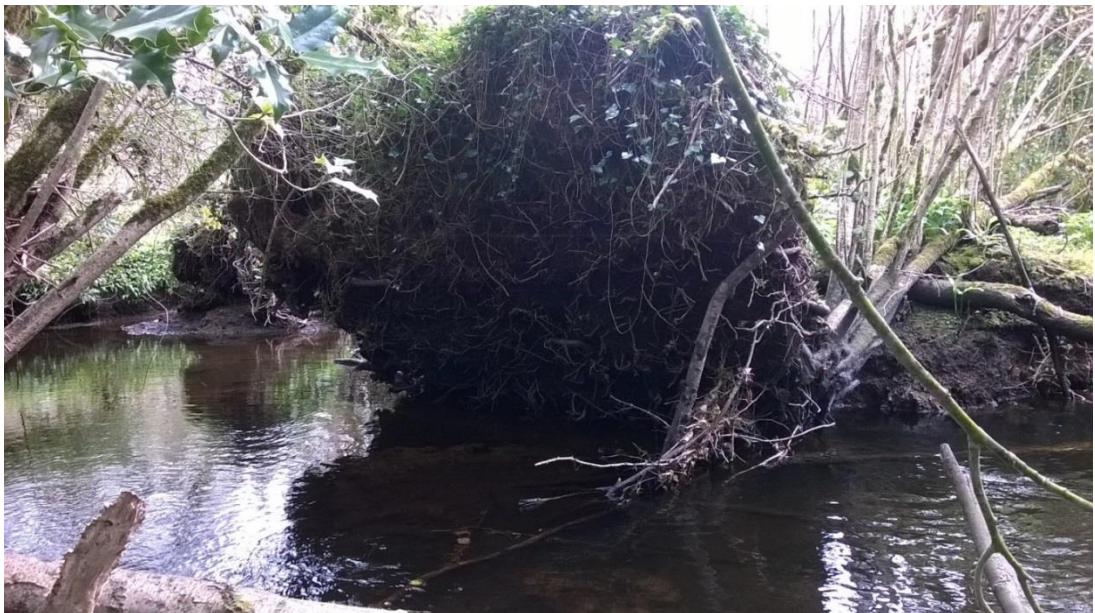
### Picture 2: Recent throw of tree's and associated erosion of islands

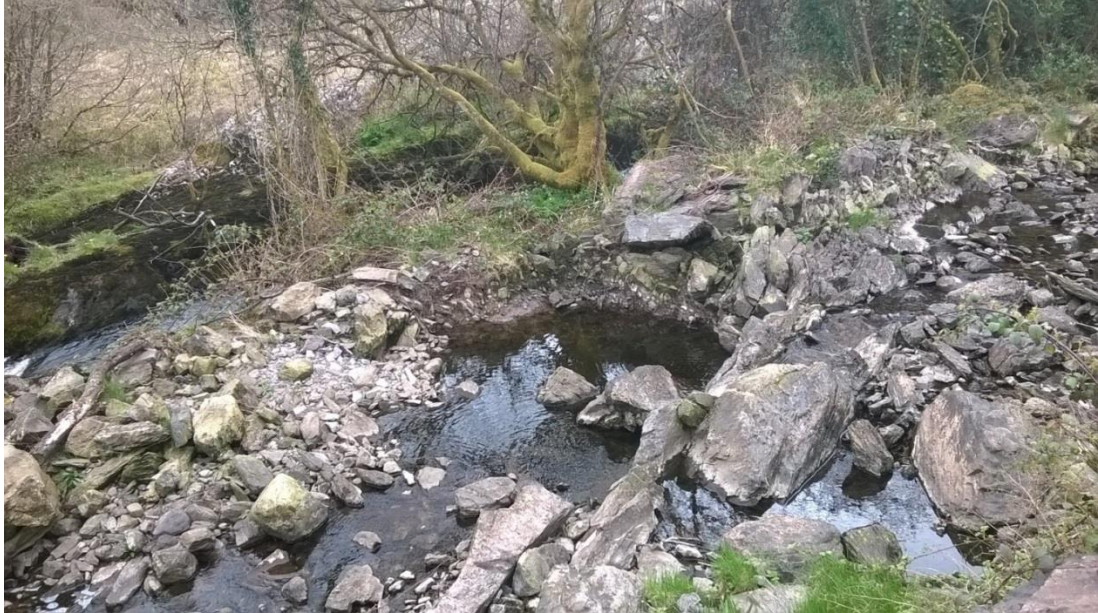
Pictures 3 and 4 at the end of this report were specifically pointed out by Mr Corcoran, being, in his view, evidence of locations where local landowners have been engaged in dredging works to reduce local flooding problems affecting a small stretch of a minor local road and agricultural lands.

My own view of these areas would be that in relation to Picture 3, without further evidence such as pictures of excavators working in the river, it would be highly arguable in a court of law whether the river channel was altered at this location as a result of human intervention or through severe and localised erosion as a result of flooding events driven by the increasing incidence of severe downpours and flash floods that seem to be happening in recent years.

**Picture 3: Upstream section of the Toon River indicating river channel modification**

- (1) It is very doubtful if planning permission was required for the activities pointed out to me by Mr Corcoran;
- (2) The characteristics of the Toon River/Lee River elements of the SAC in The Gearagh are worthy of further examination from a hydrological perspective.
- (3) The best course of action would potentially be to compose a small working group including representatives of the NPWS, ESB (who own much of The Gearagh SAC lands) to consider whether there would be merit in having the further analysis at (b) carried out with a view to developing the potential of the area as a nature reserve, conservation demonstration project and tourism asset.

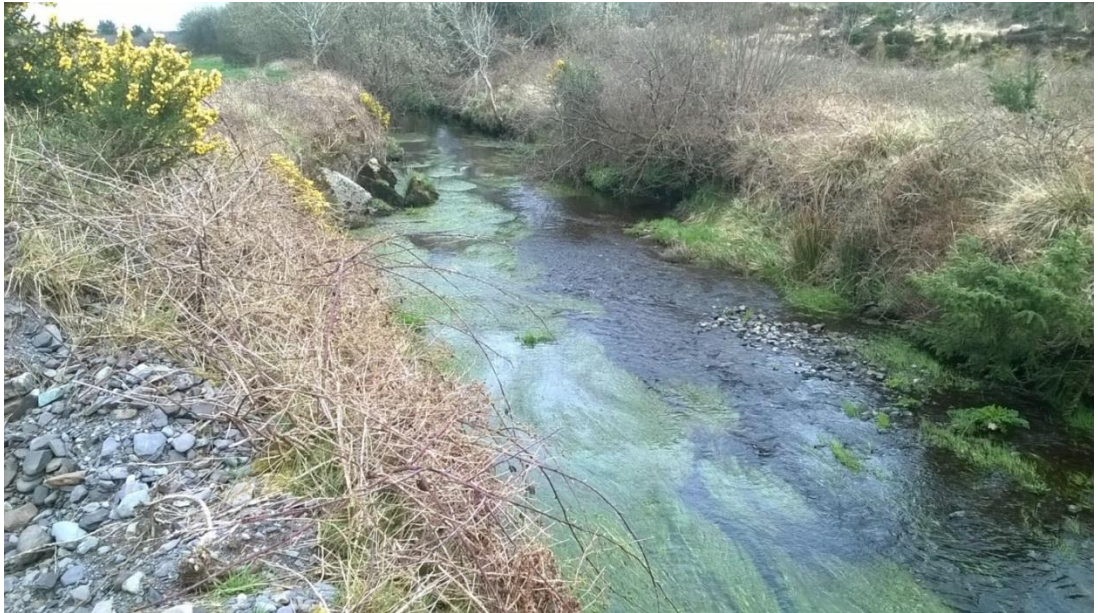
In relation to Picture 4, I would be very cautious about suggesting that simply because there is deposition of aggregates in a field beside the river that this alone indicates dredging. Again, without further evidence of the actual alleged dredging taking place, it would also be highly arguable as to whether development took place and certainly the elapse of time would present further challenges.

**Picture 4: Upstream section of Toon River: deposition of loose material alongside indicating the possibility of dredging**

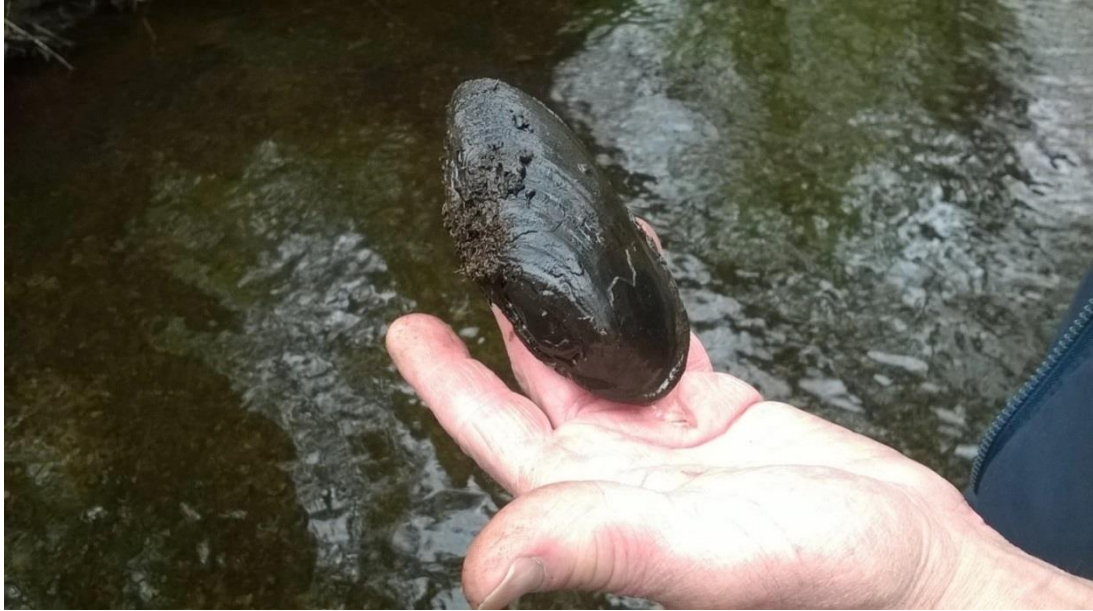
**Picture 5: Mature Fresh Water Pearl Mussel specimen in the channel of the adjacent anastomosed section of the River Lee**

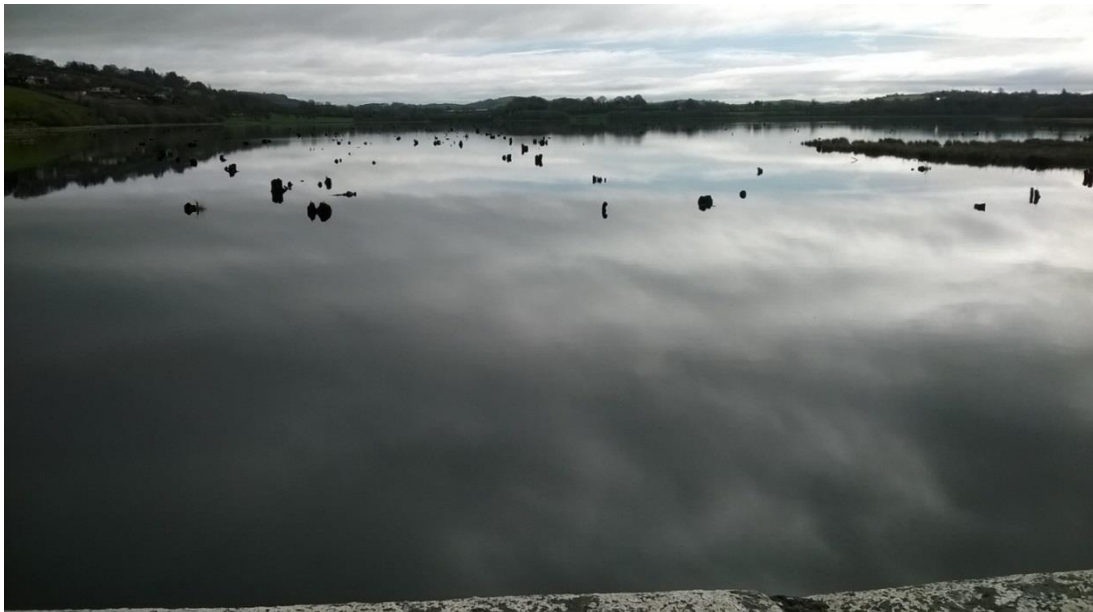
**Picture 6: The beginning of the ESB Carrigadrohid reservoir and flooded area downriver of The Gearagh**
