Gearagh Scoping Exercise Scoping Report

ESB GWM

Document No.: QD-000223-01-R101-000

Date: February 2017

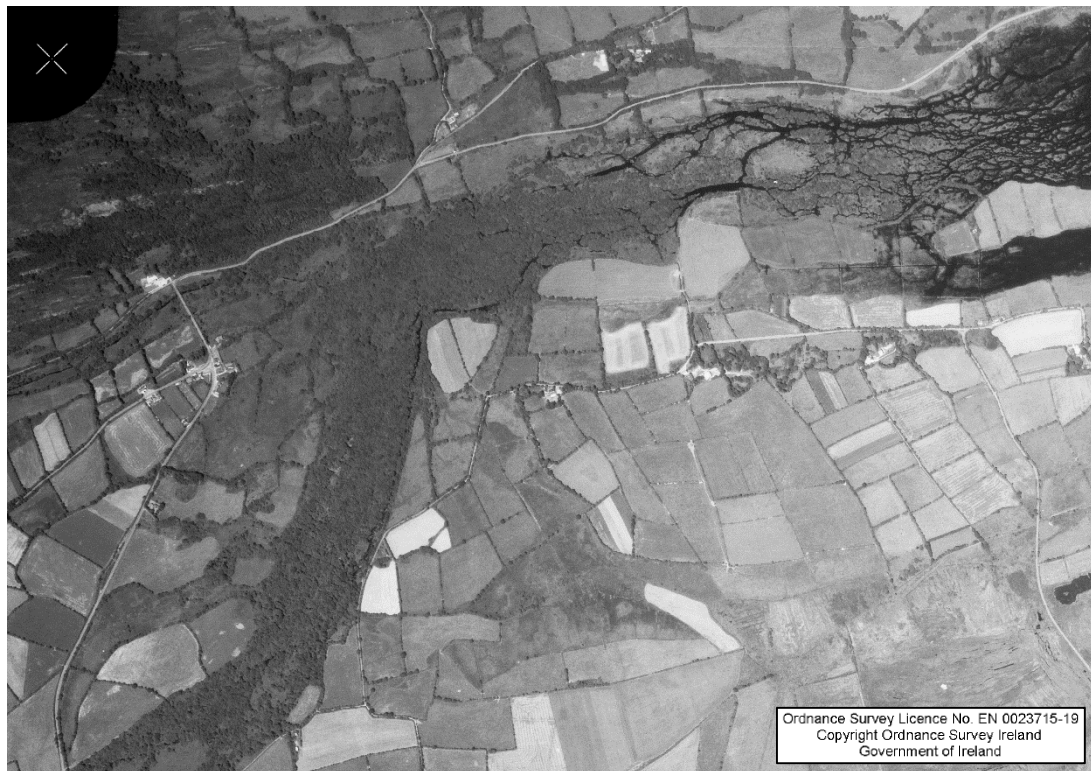
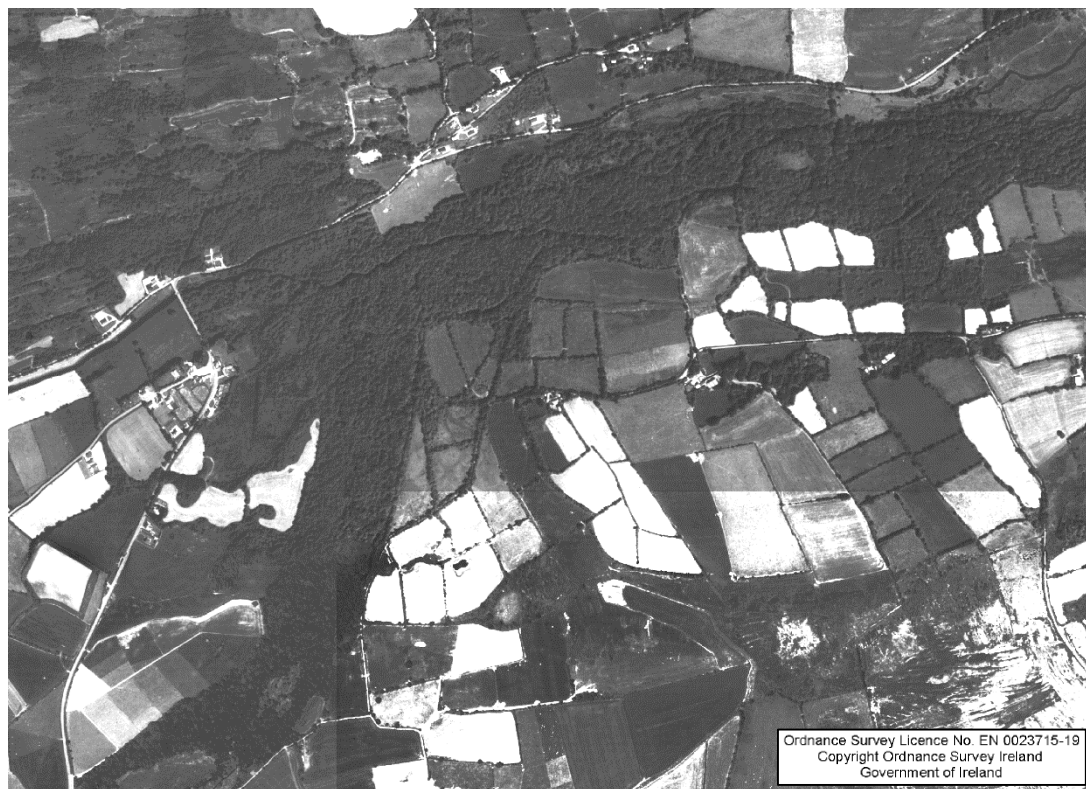
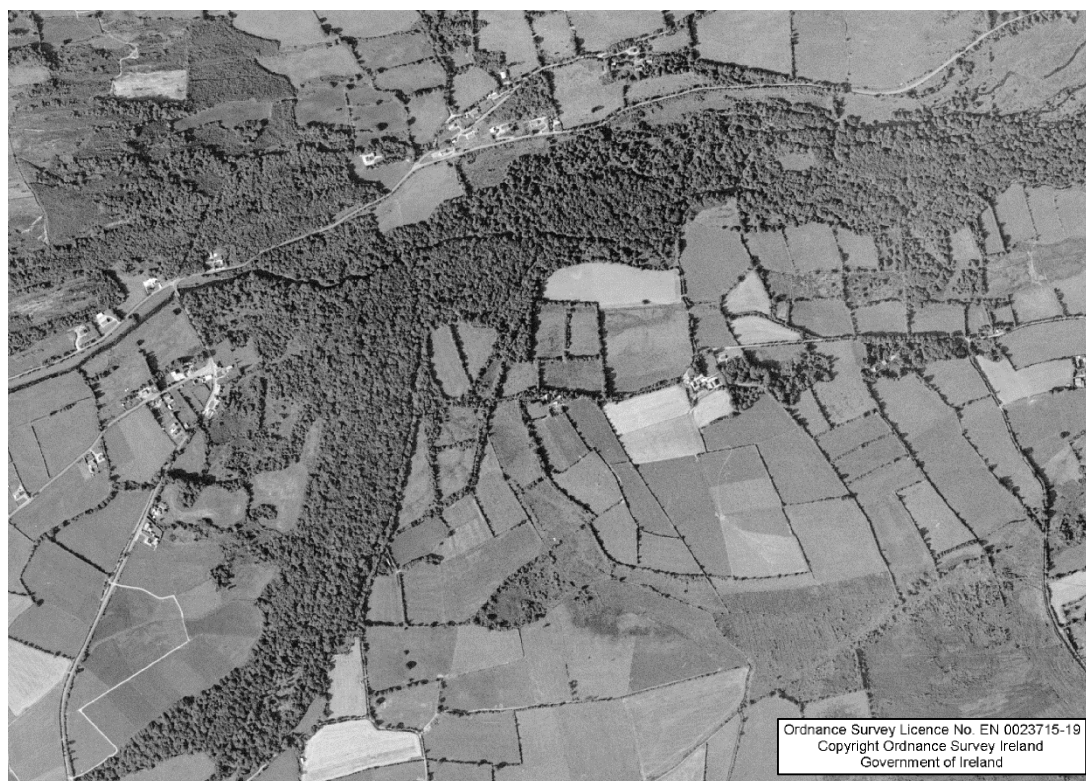
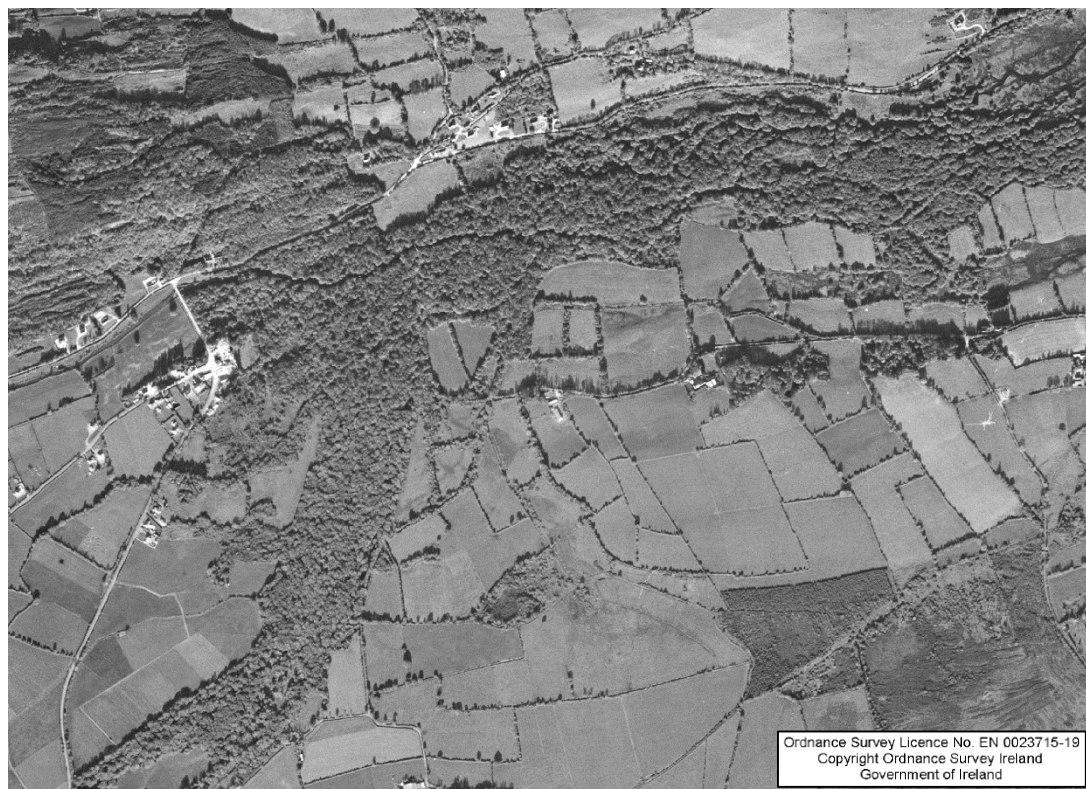
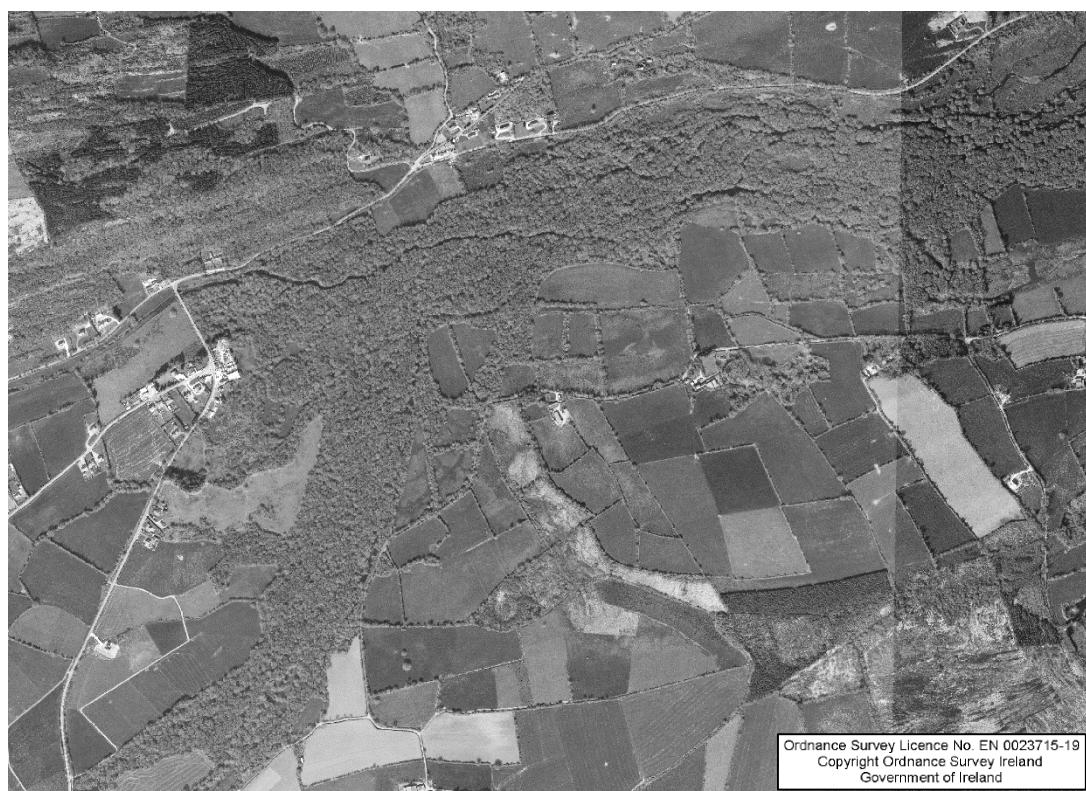
Figure 2.6: 1974 Aerial Imagery

Figure 2.7: 1995 Aerial Imagery

Figure 2.8: 2000 Aerial Imagery

Figure 2.9: 2005 Aerial Imagery

Figure 2.10: 2012 Aerial Imagery

A review of the subsequent aerial images from 2000, 2005 and 2012 is suggestive of no further significant change in the appearance of the tree canopy along the visible Toon channel; see Figure 2.6 through Figure 2.10, all presented in black and white for direct comparison. Larger versions of these maps are presented in Appendix 4.

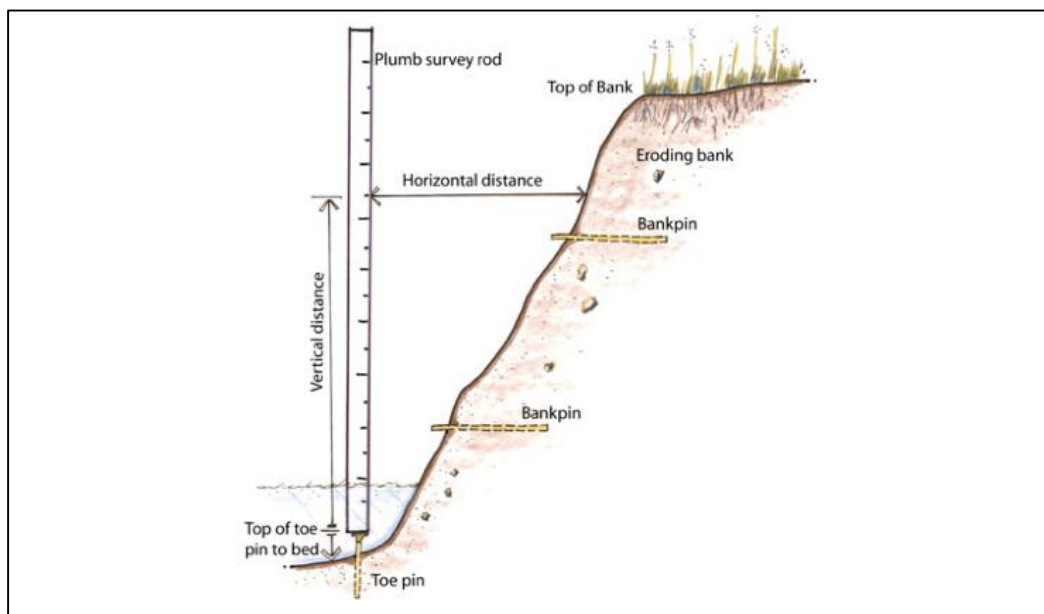
Figure 5.1: Erosion Pin Methodology

A passive monitoring scheme relating to potential erosion of bank and islet soils will be established through the use of 'erosion pins'. With careful placement of such pins they can provide a good estimate lateral adjustment over time, and are an extremely economic approach. This is a simple technique that comprises of driving pins into the face of a river bank. While any material that will not decay is suitable, a small diameter metal pin is preferable as large pins may themselves lead to localised scour. The pin should be stable and perpendicular to the bank face. Pins will be of a sufficient length (minimum 1 m) to negate the risk of them becoming dislodged from an eroding bank face and washing into the river.

The section of the pin protruding from the bank is measured directly using a tape measure. This should be carried out periodically although, as outlined with previous techniques, a responsive approach should be adopted so that data is collected after high flow events. The deliverables are readings of the length of each pin that is exposed at each individual location at each survey date. This will provide an estimate of the amount of erosion that has occurred at the location between two sampling dates. A network of such pins could be established within the woodland, with their precise locations established via GPS to facilitate repeat surveys. Again, the monitoring network will comprise points along the dominant Toon River channel and some of the smaller channels parallel to the dominant channel, as well as a number of control points established along the anastomosed course of the River Lee.
